BOYD KELLER RESERVOIR DAM

INVENTORY NUMBER NDS 745

## PHASE I INSPECTION REPORT

## PHASE I REPORT NATIONAL DAM INSPECTION PROGRAM

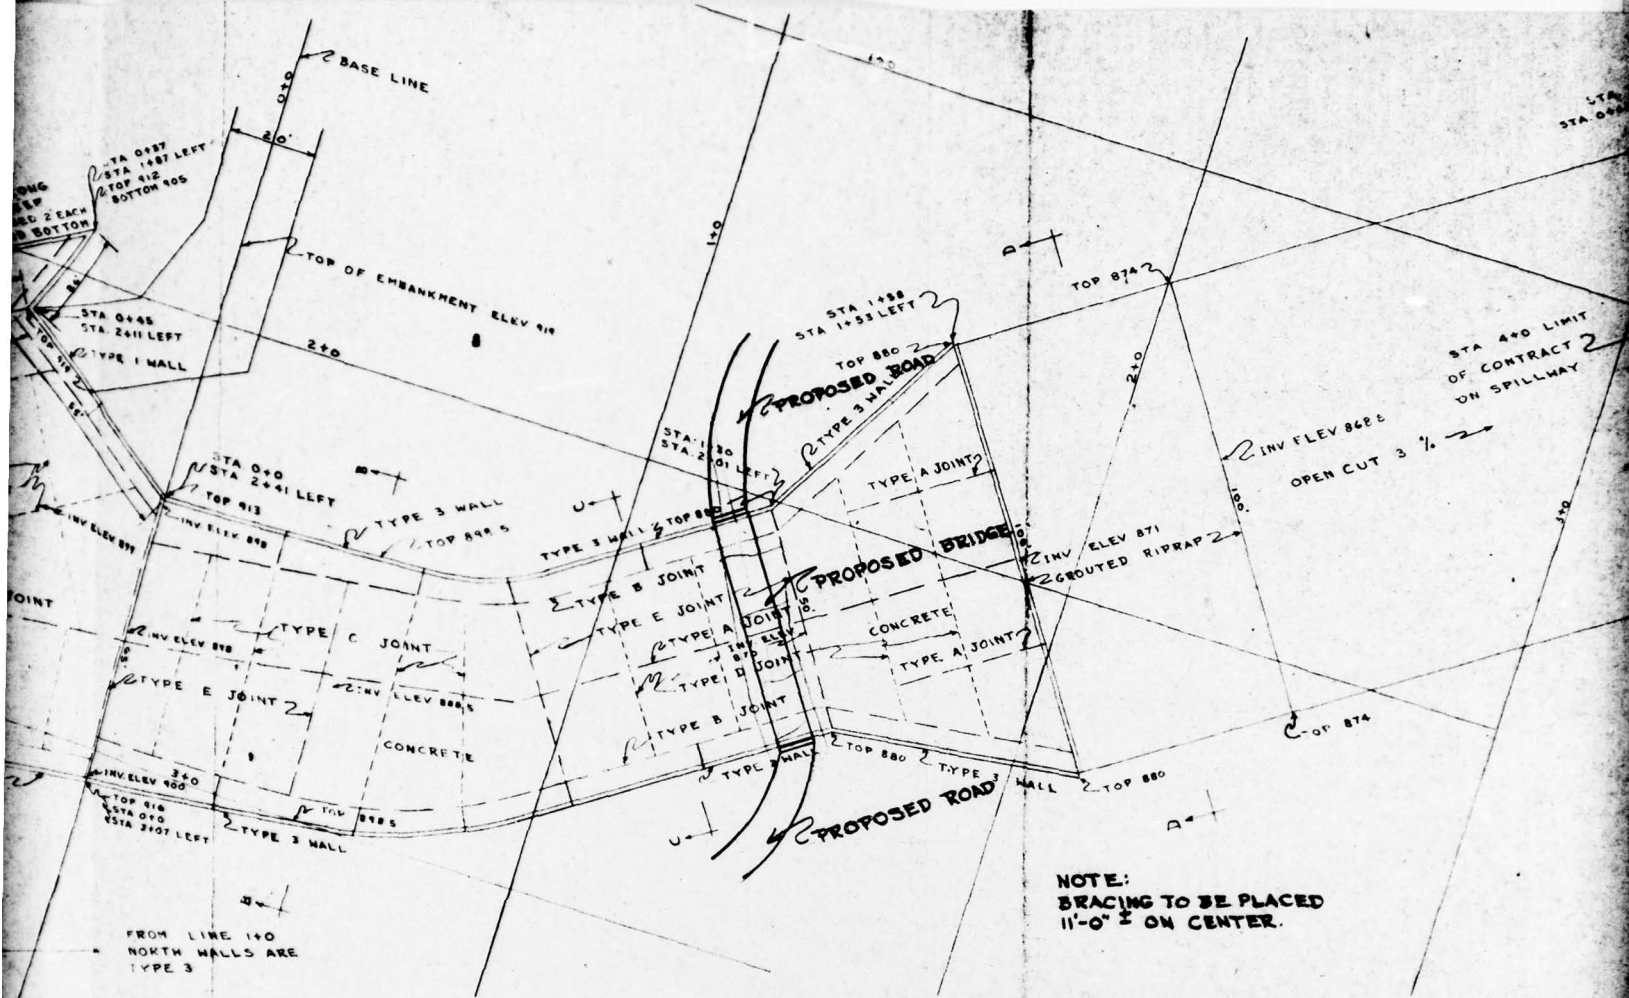
745  
PLATE VII

The dam was designed by Hill and Hill Engineers, North East, Pennsylvania. A permit for construction was granted in March, 1956, and construction was started in April, 1956. Since an existing water supply dam at this location was inadequate to meet the demands of the city, a higher dam, with increased storage was needed. The new spillway was constructed at the right abutment. The existing concrete corewall was utilized in the new embankment fill (Appendix D, Plate VII).

One drawing included with the contract drawings is a detail of the foundation conditions of the core wall constructed in 1912-15. This drawing indicates a portion of the corewall was constructed on "hardpan", since rock was evidently at a grade too low to reach.

There are no design criteria for the embankment stability available. The construction drawings indicate good foundations for vertical loads. The small amount of grouting accomplished in 1915 at the right abutment would have little effect on the overall volume of leakage through the foundations. The amount of seepage is relatively constant and there is no turbidity in the water. The present dam was constructed in 1956 and incorporates some of the features of the old dam (See Appendix D, Plate VII). The slopes of the embankment appear to be adequate.
